ASSESSMENT OF TWO CITY OF FRANKLIN CEMETERIES, FRANKLIN, TENNESSEE

Chicora Research Contribution 559

Michael Trinkley
Debi Hacker

September 2014

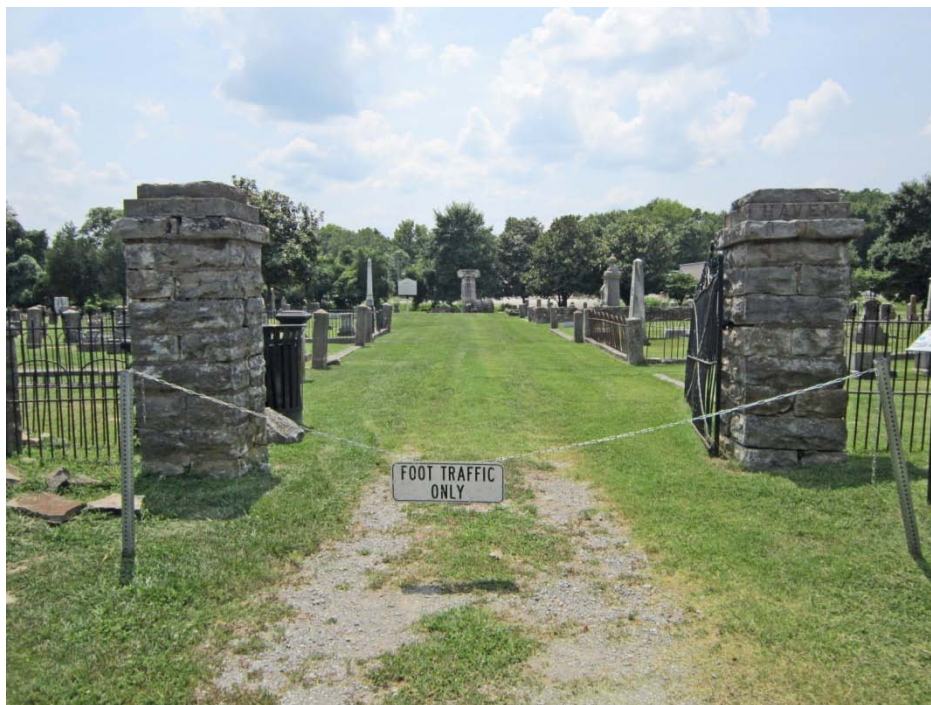
Figure 19. East entrance looking west at Rest Haven. The chain should be removed and replaced with a removable bollard.

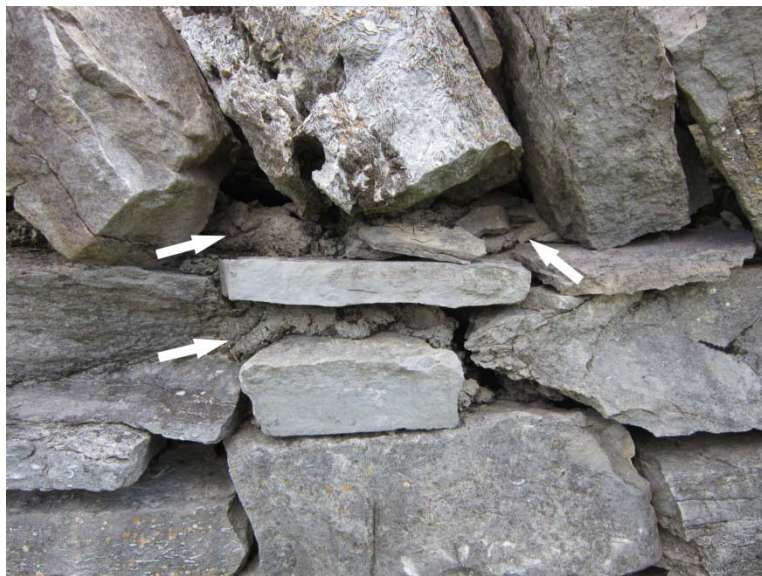
Figure 24. Evidence of hard Portland cement mortar in some areas of the walls.

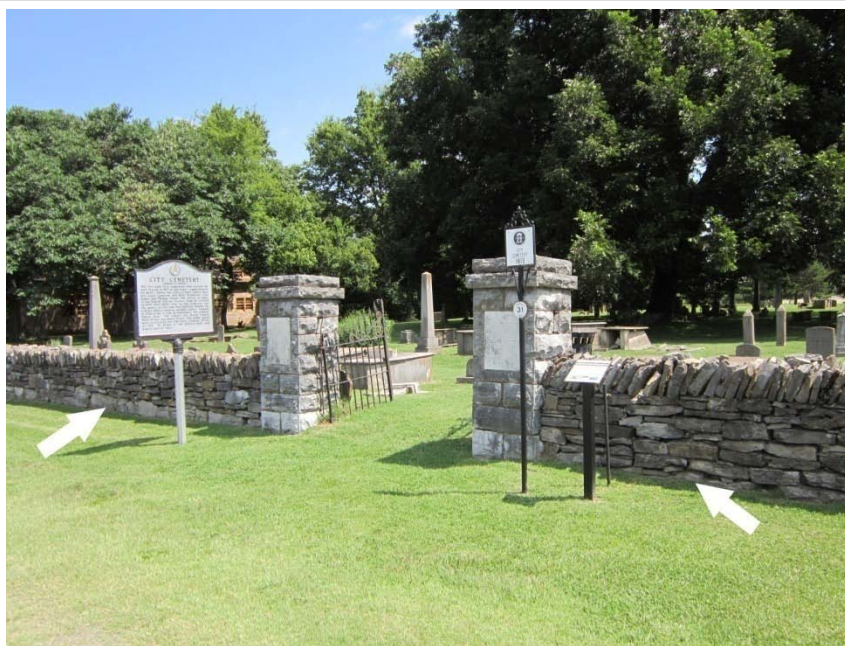
Figure 25. Different base construction north and south of the west gate.

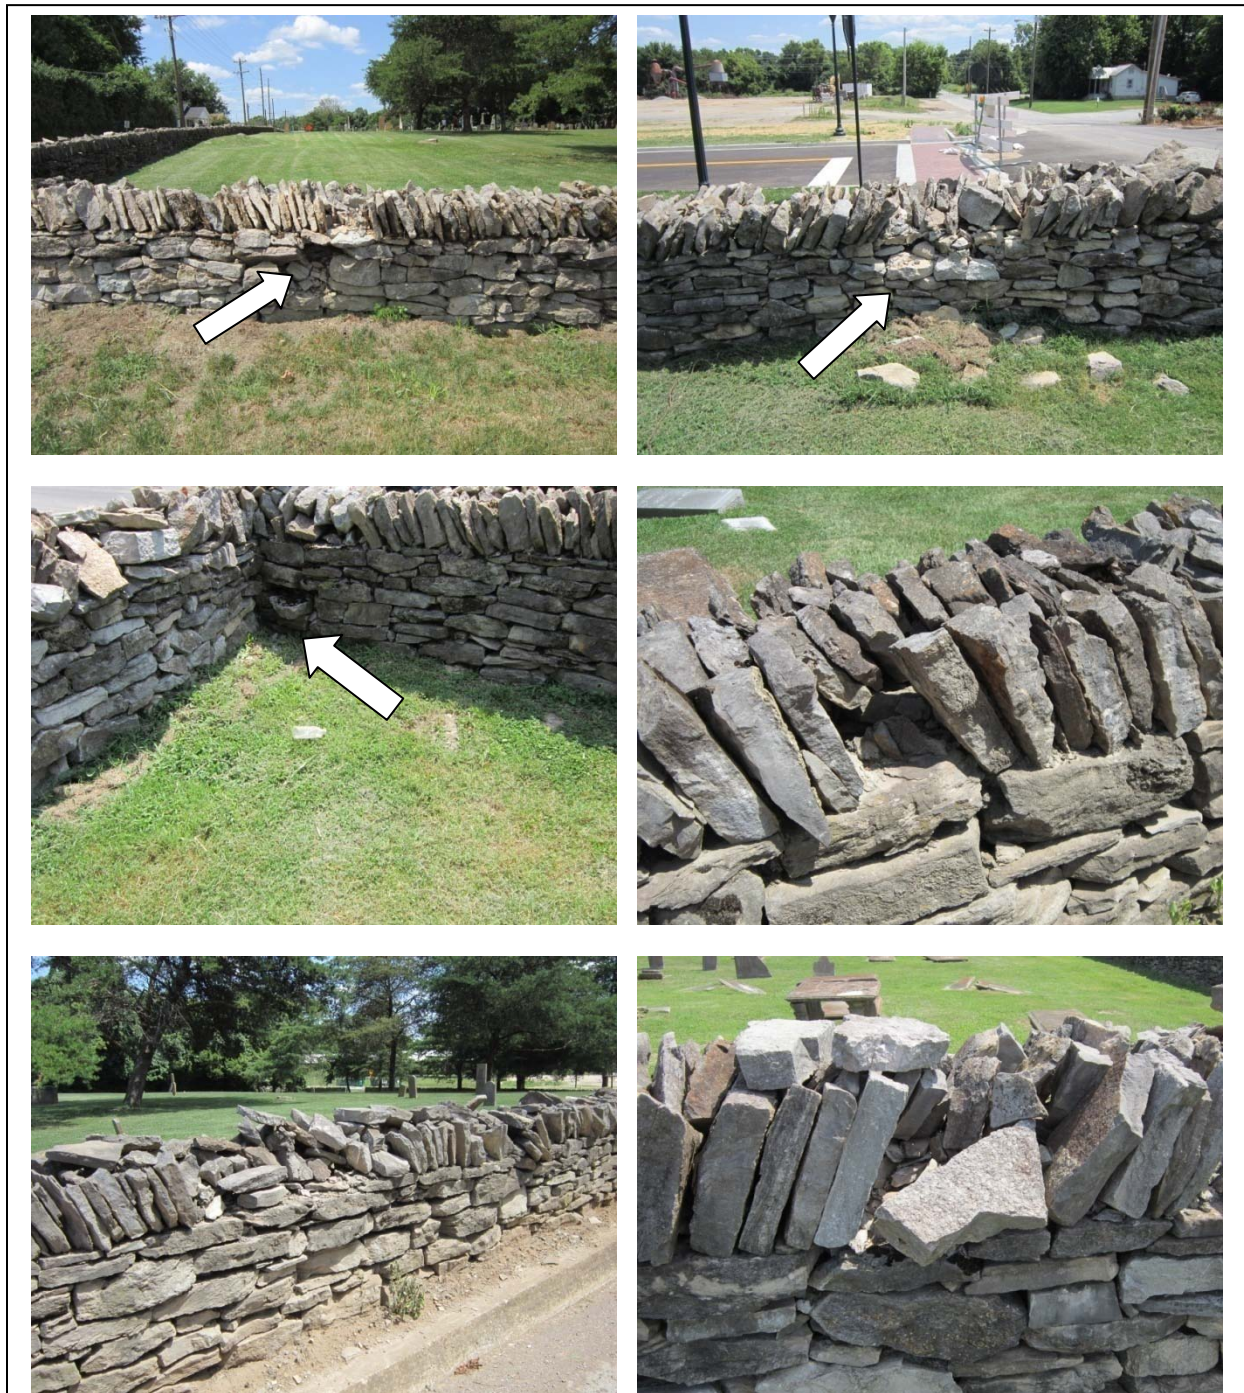
Figure 26. City Cemetery stone wall defects. Upper row shows damage to the eastern wall, exterior (left) and interior (right). Middle left, southeast interior corner showing stone loss. Middle right, south exterior loss of capping stones. Lower left, jumbled and dumped capping stones on the south wall. Lower right, west wall damaged cap.

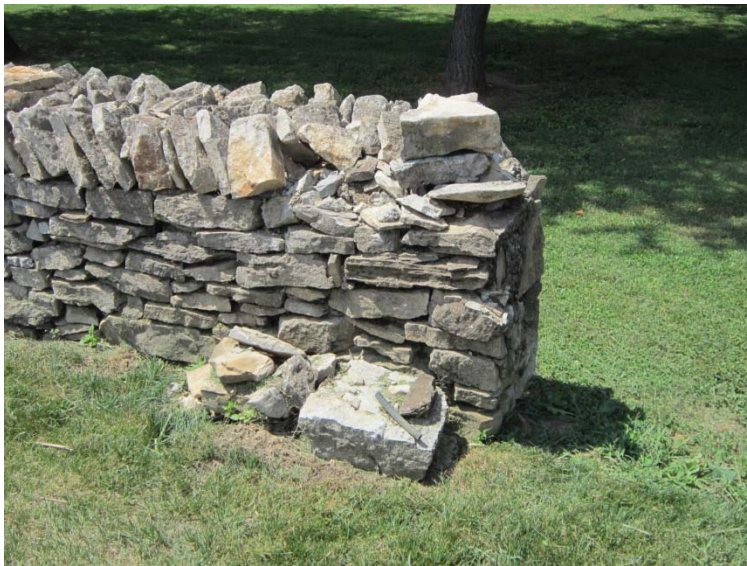
Figure 28. South end of the east gate showing the missing granite stroup.

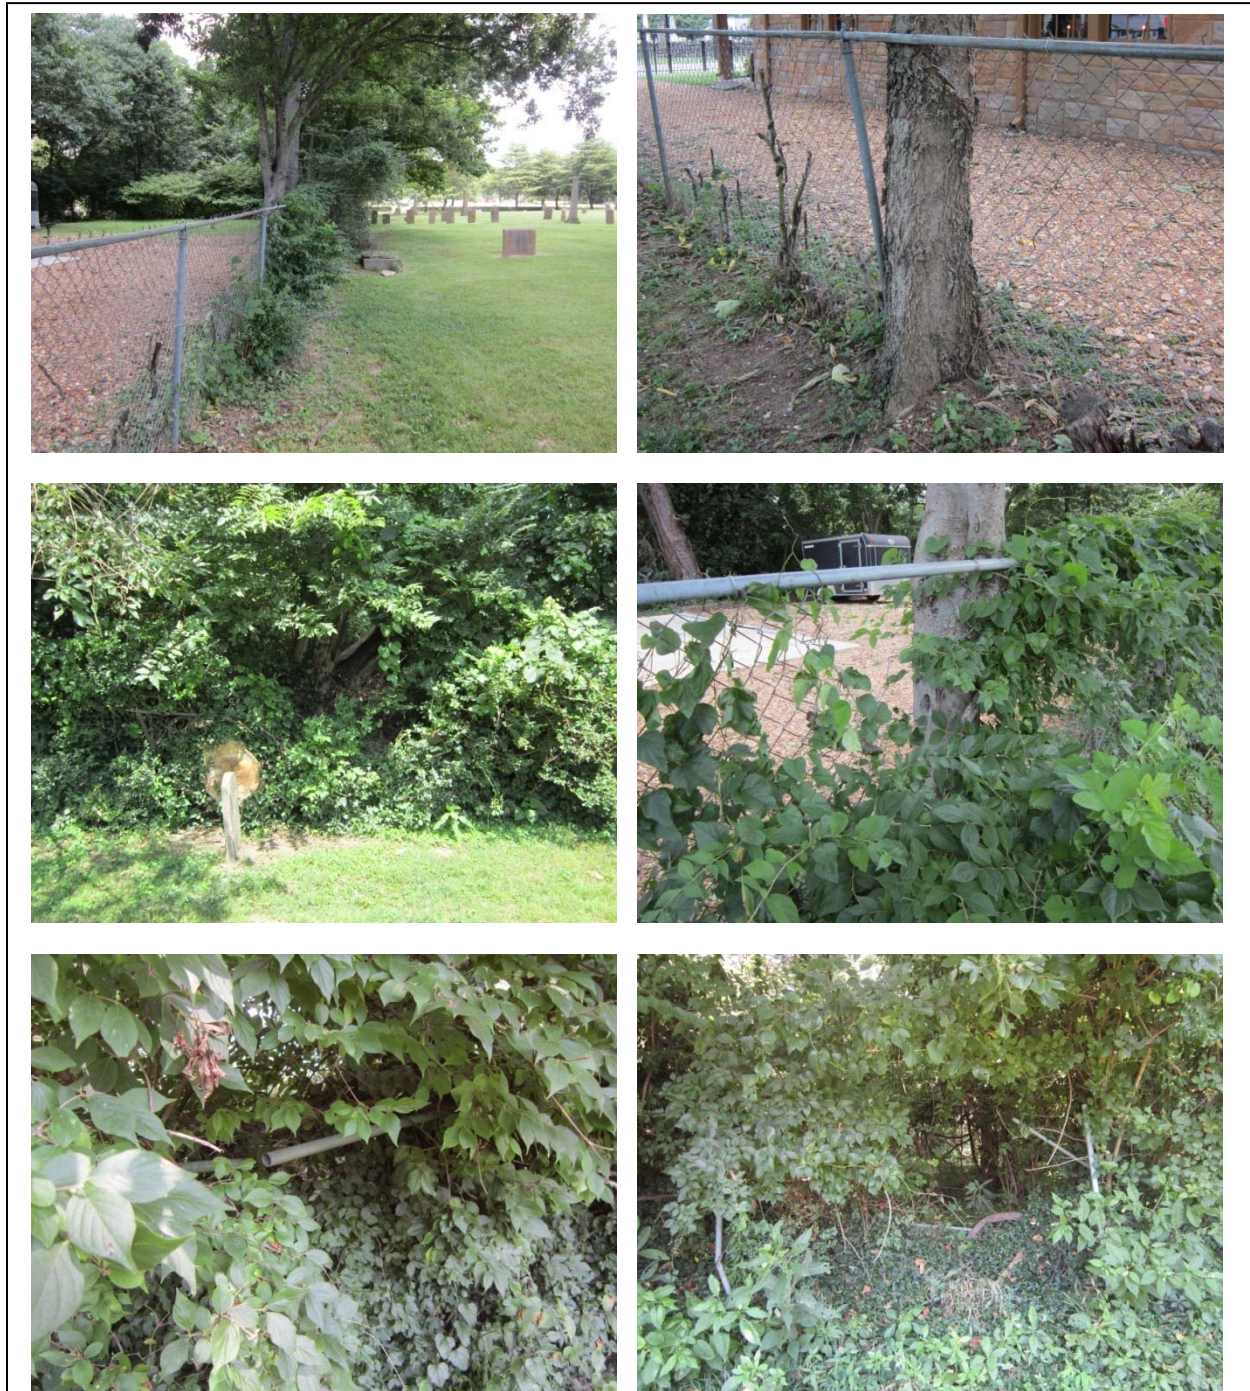
Figure 29. Chain link fence along the north property line. Upper left, vines and other vegetation should be removed from the fence. Limbs from adjoining property should be removed to the property line. Upper right shows a tree grown into the fence. Middle left shows a tree fallen on the fence. Middle right shows a second tree growing into the fence which must also be removed. Lower left shows a damaged and bent top rail. Lower right shows a section of fence that is totally down.

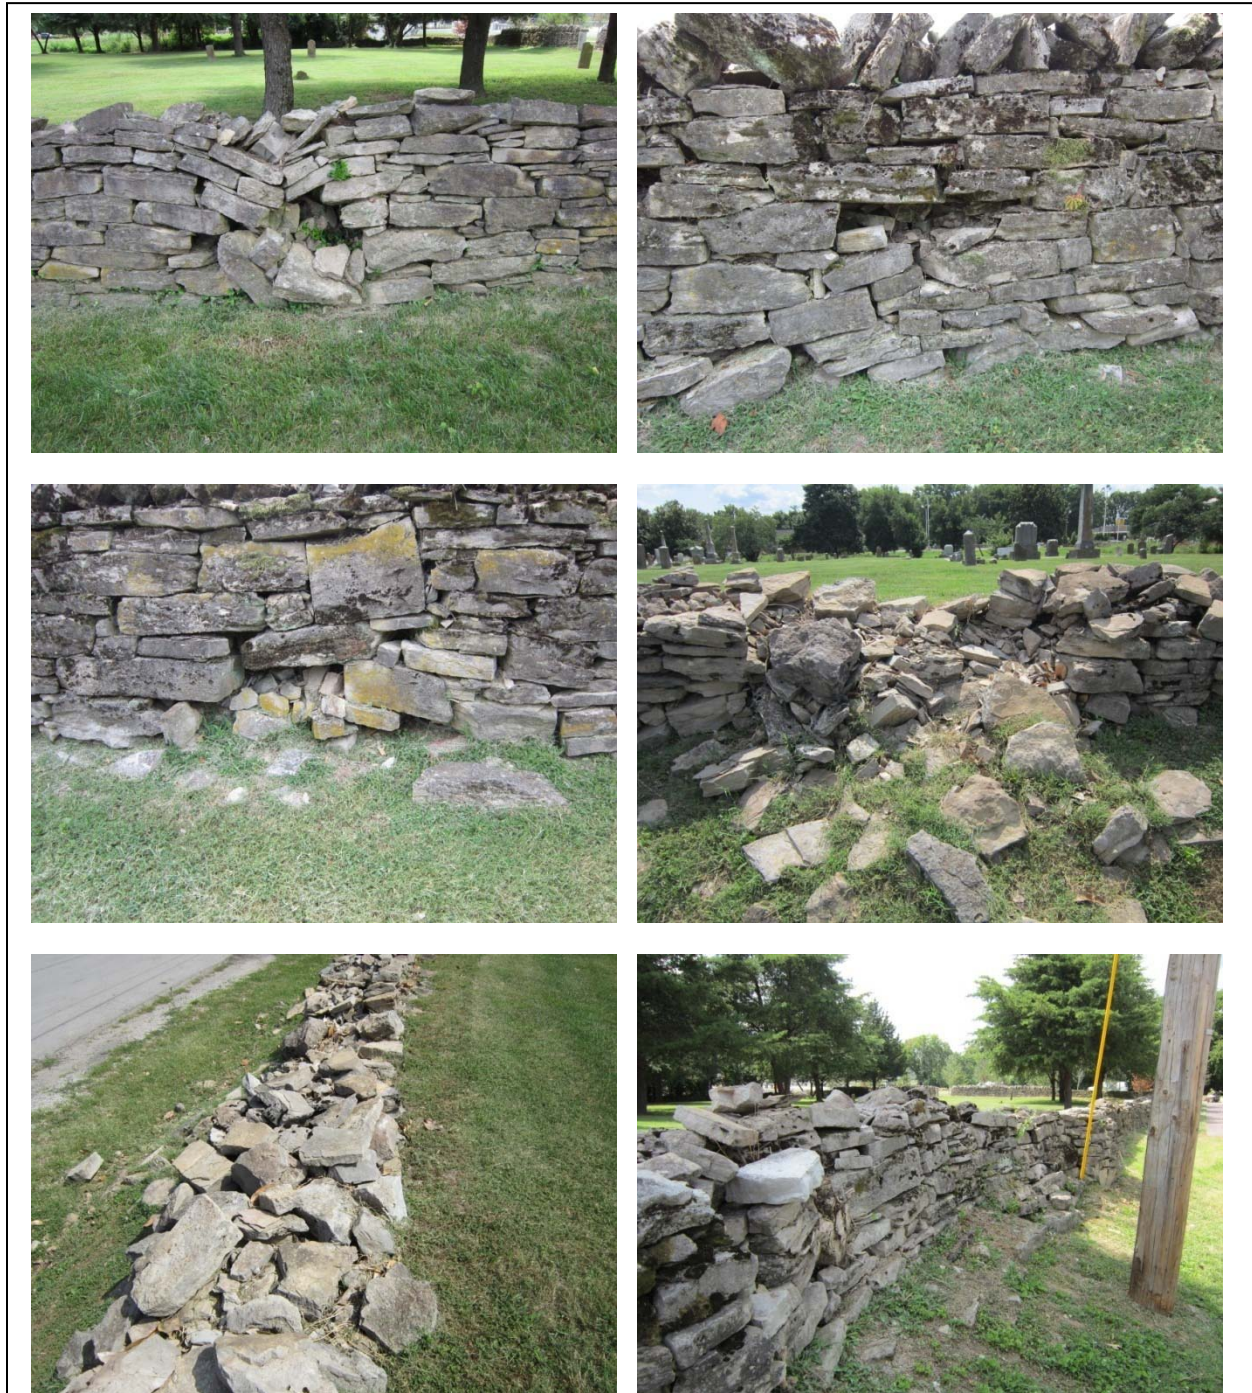
Figure 30. Condition of the stone wall at Rest Haven Cemetery. Upper left shows a slump on the east exterior wall. Upper right shows stone loss and incipient slump on the east wall. Middle left, stone loss with stones partially buried in the soil beyond the wall. Middle right shows more extensive area of wall collapse. Lower left shows total collapse of the wall. Lower right shows bowing of the wall.

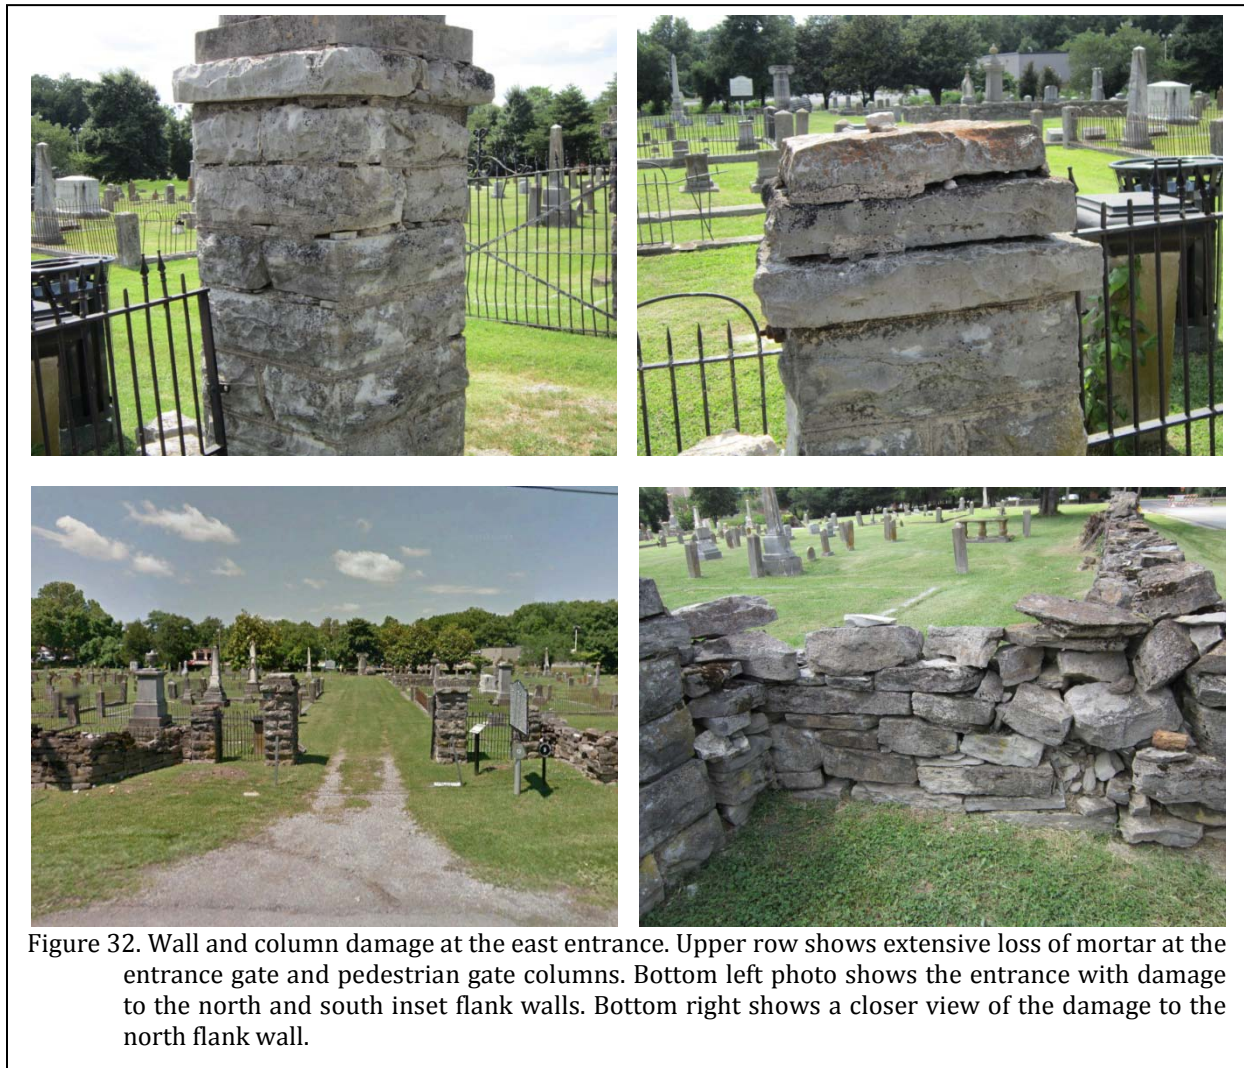
Figure 32. Wall and column damage at the east entrance. Upper row shows extensive loss of mortar at the entrance gate and pedestrian gate columns. Bottom left photo shows the entrance with damage to the north and south inset flank walls. Bottom right shows a closer view of the damage to the north flank wall.

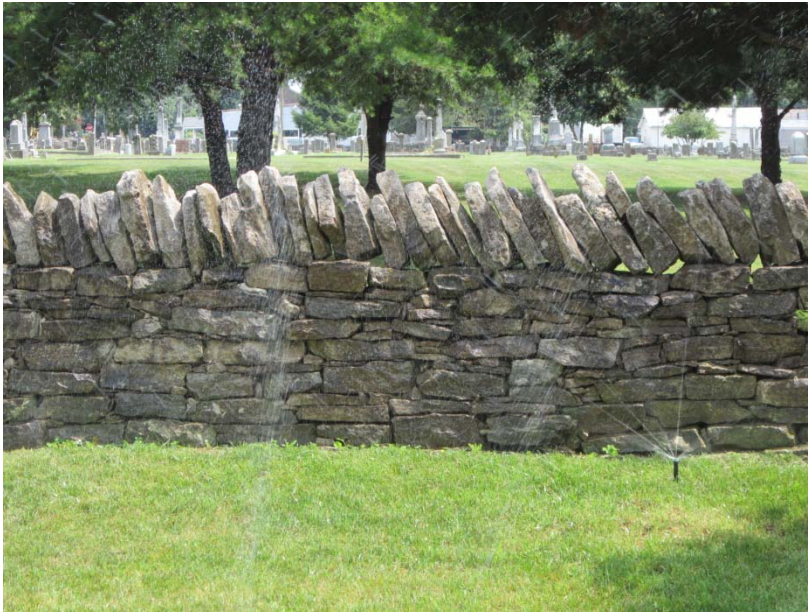
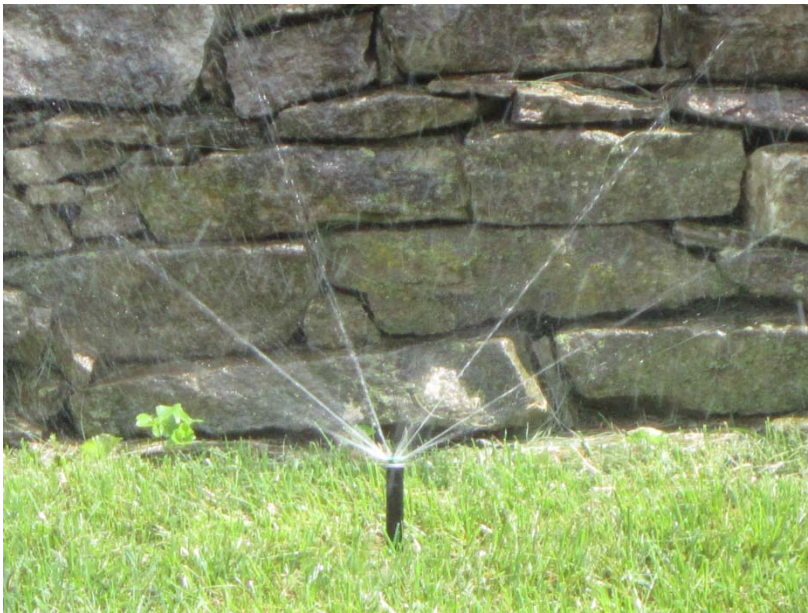
Figure 33. Sprinklers wetting the north cemetery wall should be removed or adjusted to ensure the wall remains dry.

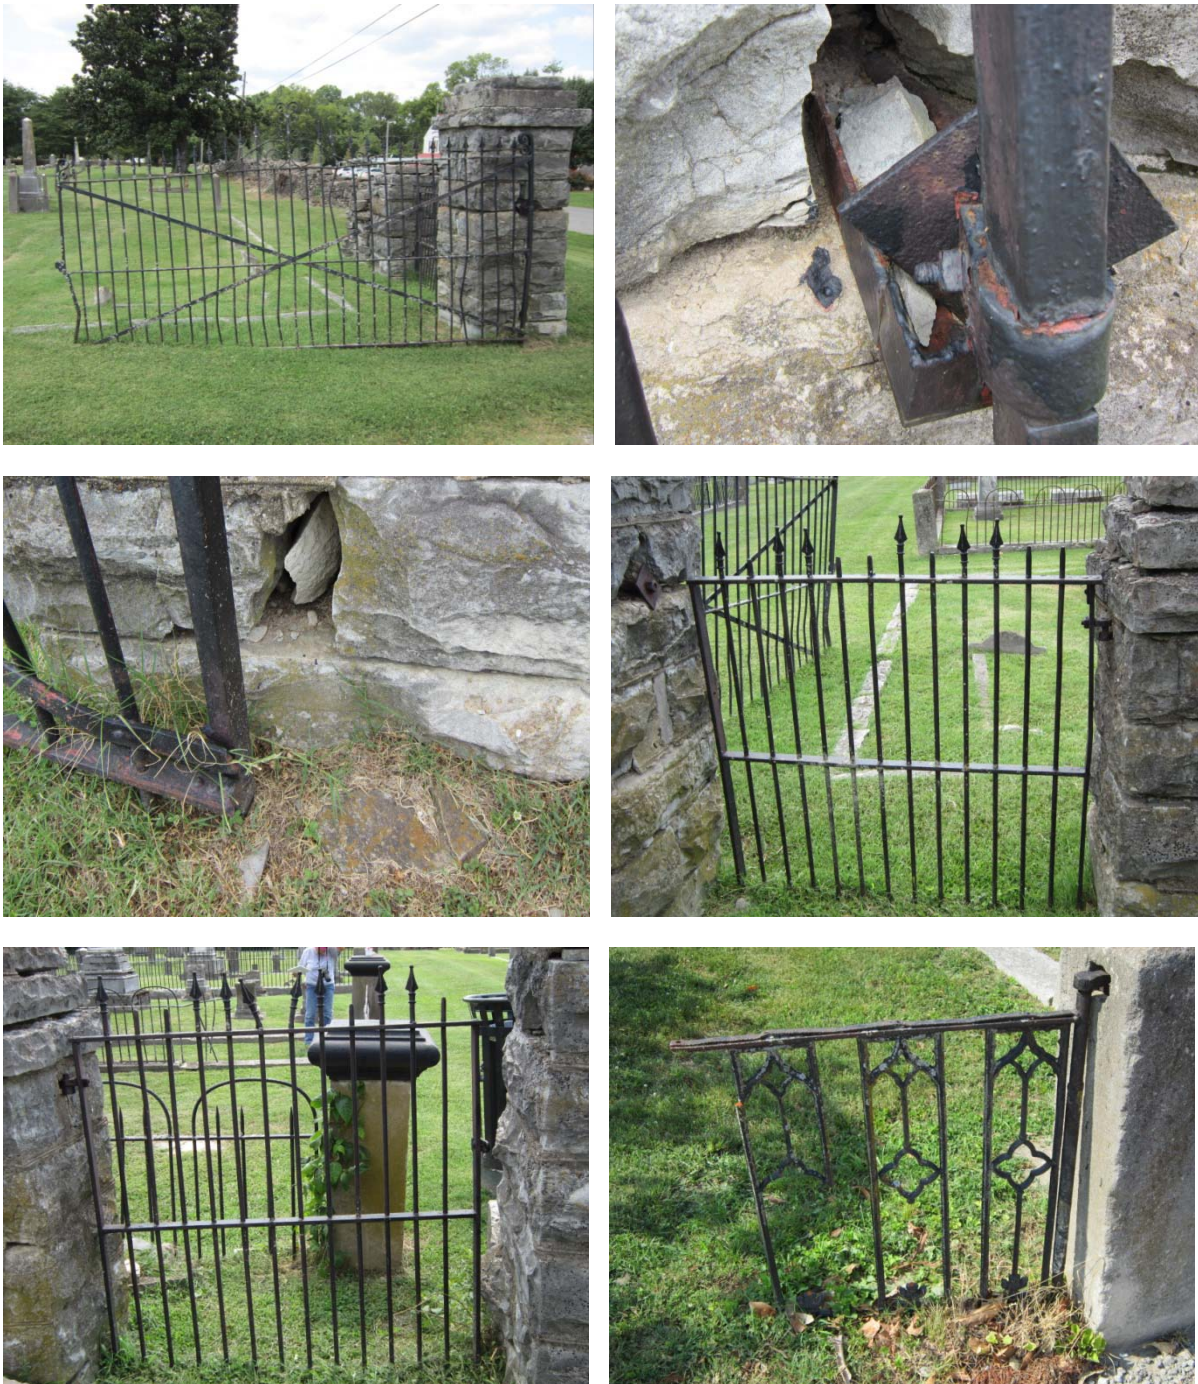
Figure 34. Gate problems. Upper left is the east drive gate showing damage. Upper right is the upper drive gate hinge showing damage to the stone column. Middle left shows the lower drive gate hinge. Middle right shows the northern pedestrian gate. Lower left shows the southern pedestrian gate. Lower right shows the small southern pedestrian gate with the missing section to the west.

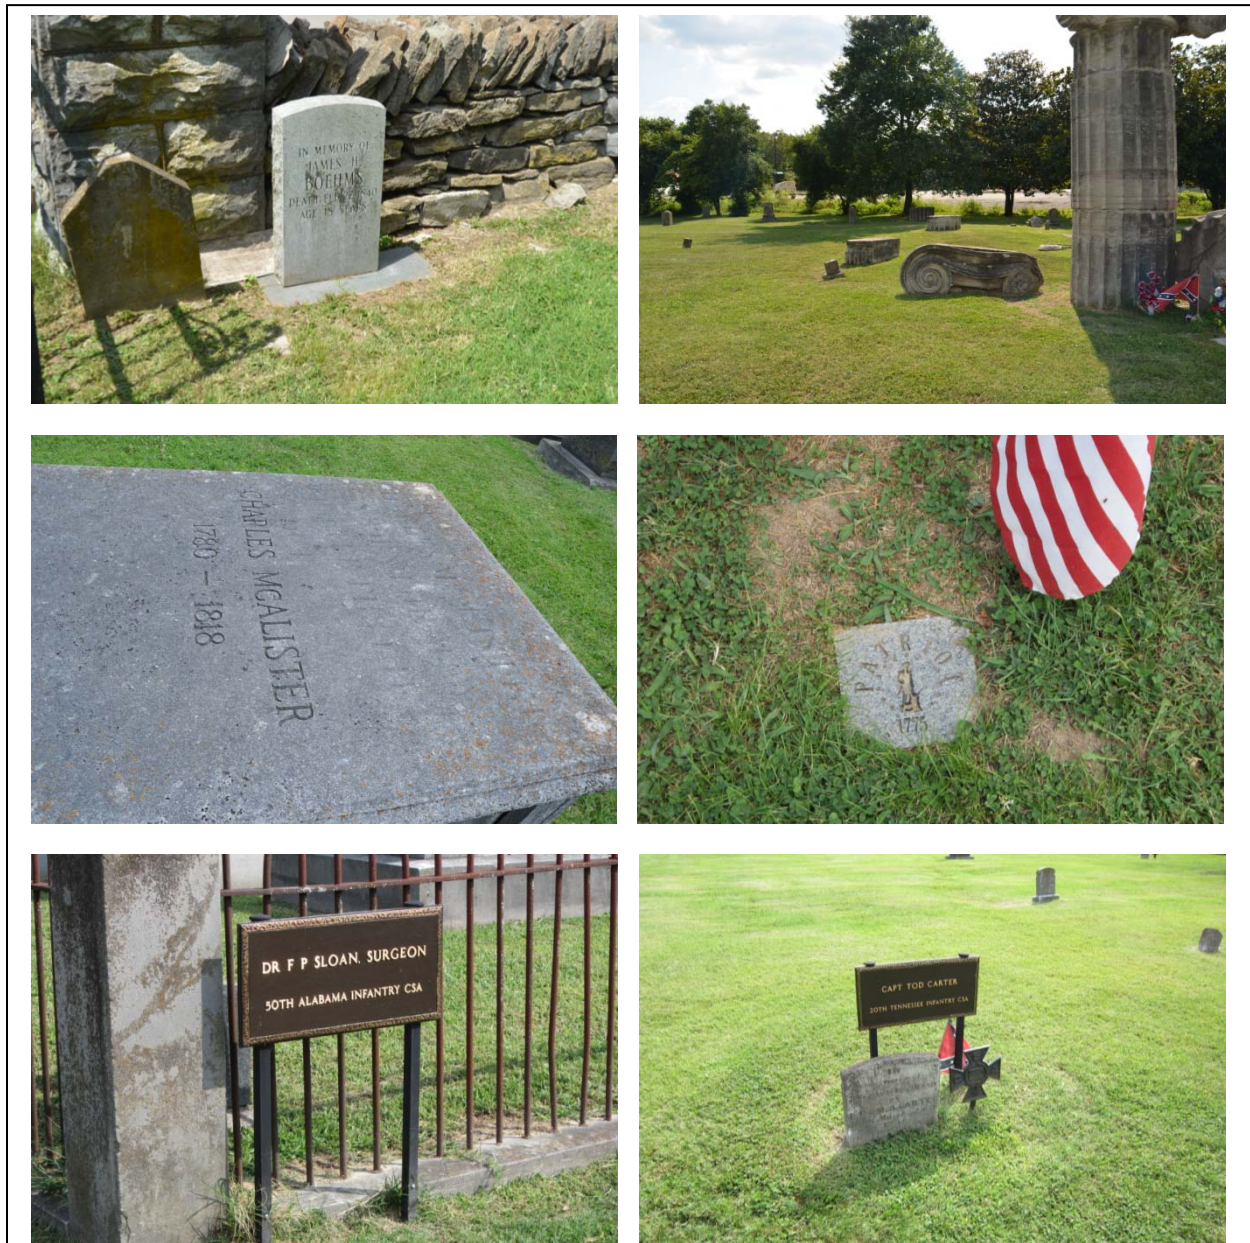
Figure 39. Introduction of new elements. Upper left shows an inappropriate style monument introduced into City Cemetery. Upper right shows the monument to the unknown soldier that is out of scale with the cemetery and all other monuments. Middle left shows recarving of a monument which damages the original historic fabric and should never be allowed. Middle right shows an acceptable flush mounted emblem that doesn't detract from the cemetery landscape. The lower two photographs show examples of inappropriate markers that should be removed since the graves are already well marked or minimally should be laid as flush lawn markers.

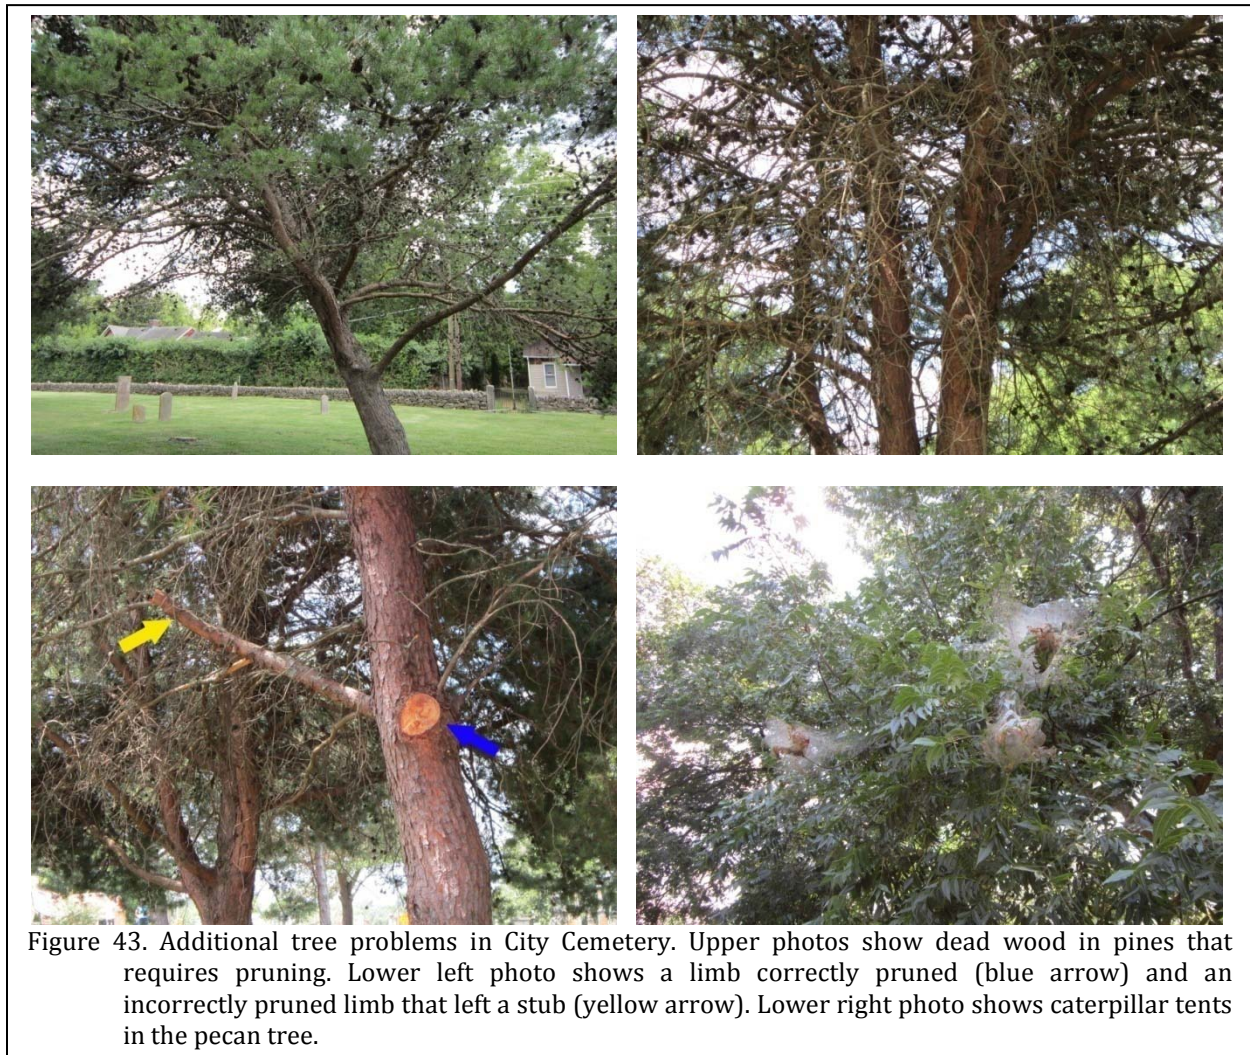
Figure 43. Additional tree problems in City Cemetery. Upper photos show dead wood in pines that requires pruning. Lower left photo shows a limb correctly pruned (blue arrow) and an incorrectly pruned limb that left a stub (yellow arrow). Lower right photo shows caterpillar tents in the pecan tree.

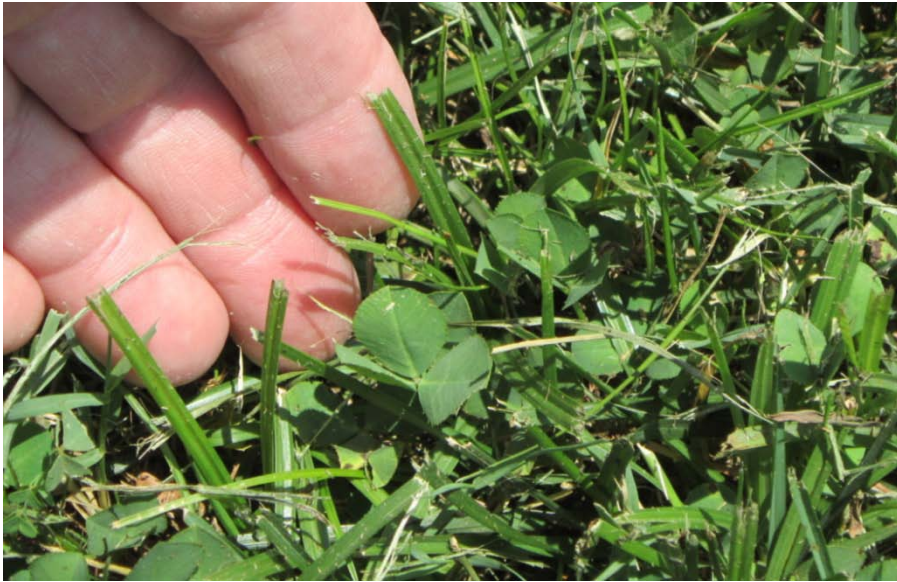
Figure 47. Mower blades could be sharper, but there is relatively little tearing of the grass at City Cemetery.

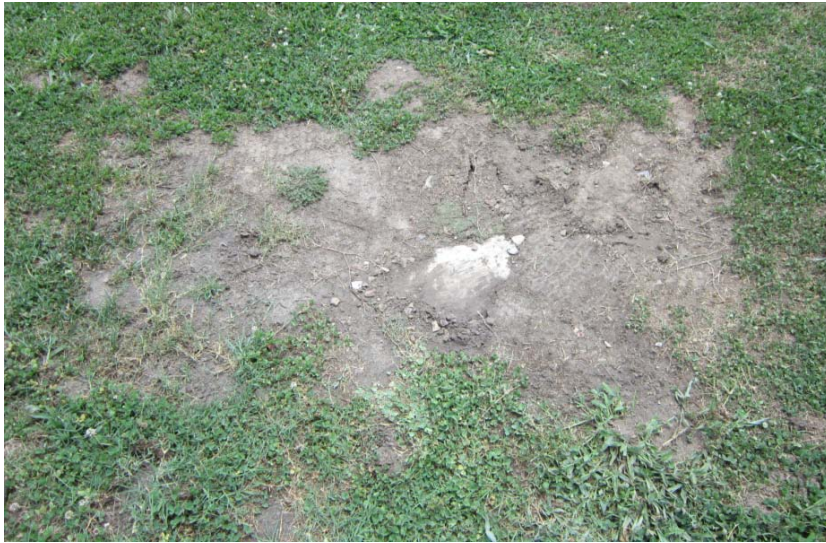
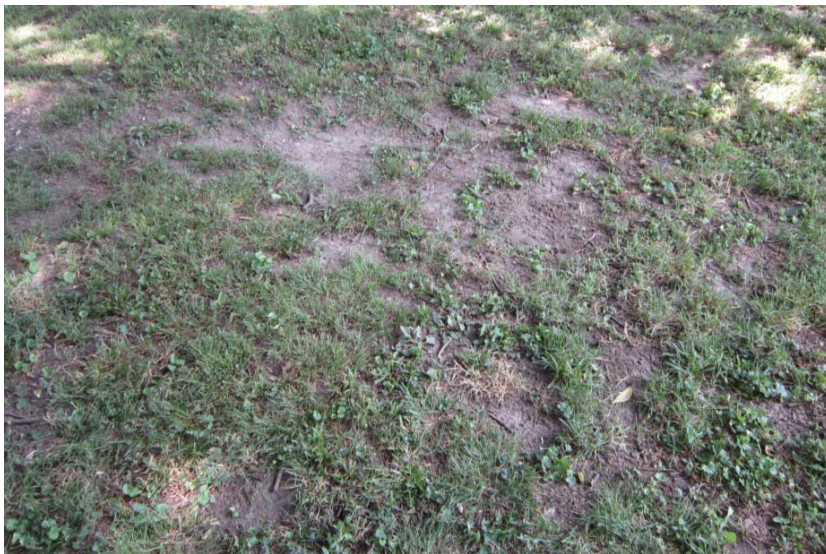
Figure 48. Examples of a bare spots in the cemetery. In the upper photo there is a fallen monument almost totally covered by soil.

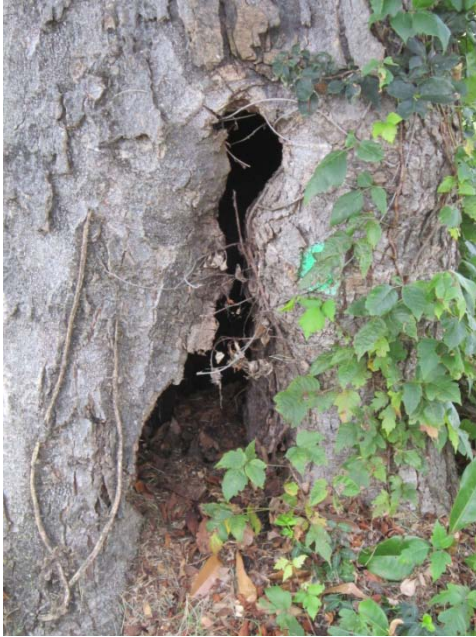
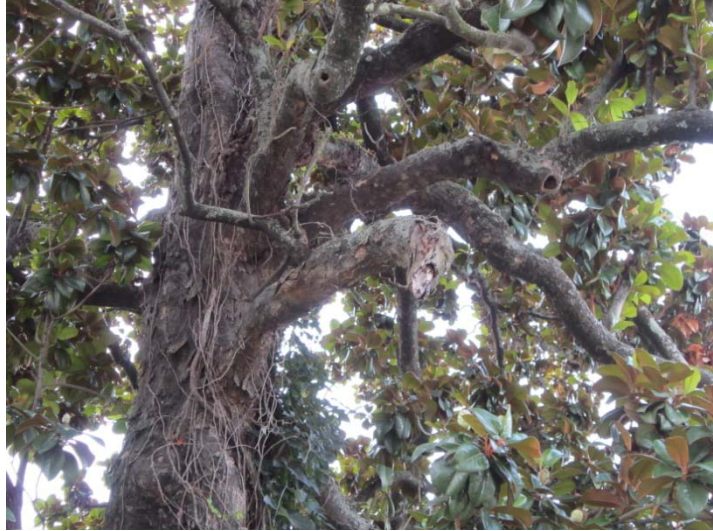
Figure 49. Magnolia at the east side of the cemetery. The photo on the left shows the hollow trunk. The right photo shows the abundant dead wood in the canopy that requires removal if the tree is not being removed.

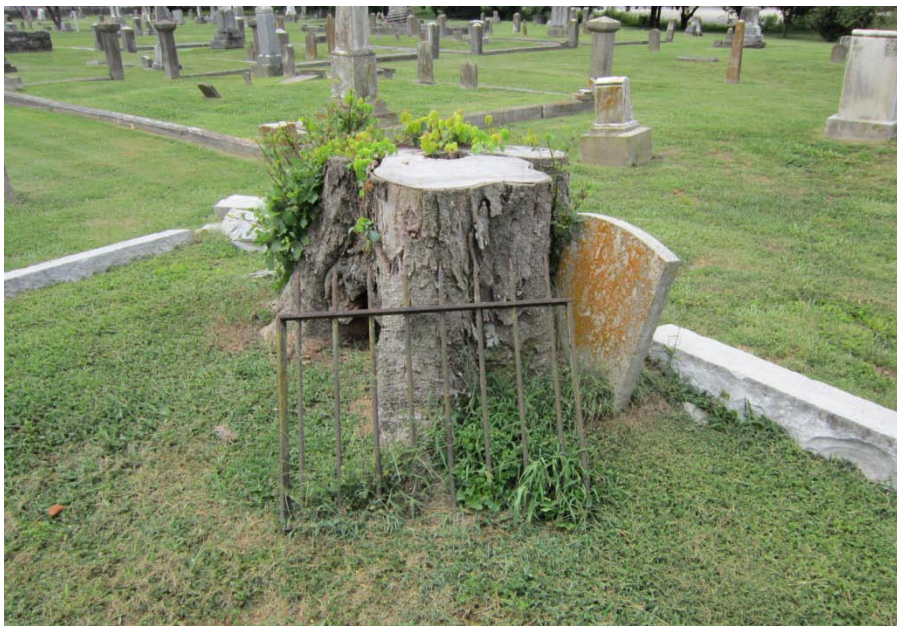
Figure 51. Improper cutting of stumps. Stumps should be cut flush to the ground and allowed to gradually decay. Stump grinders should never be used in the cemetery.

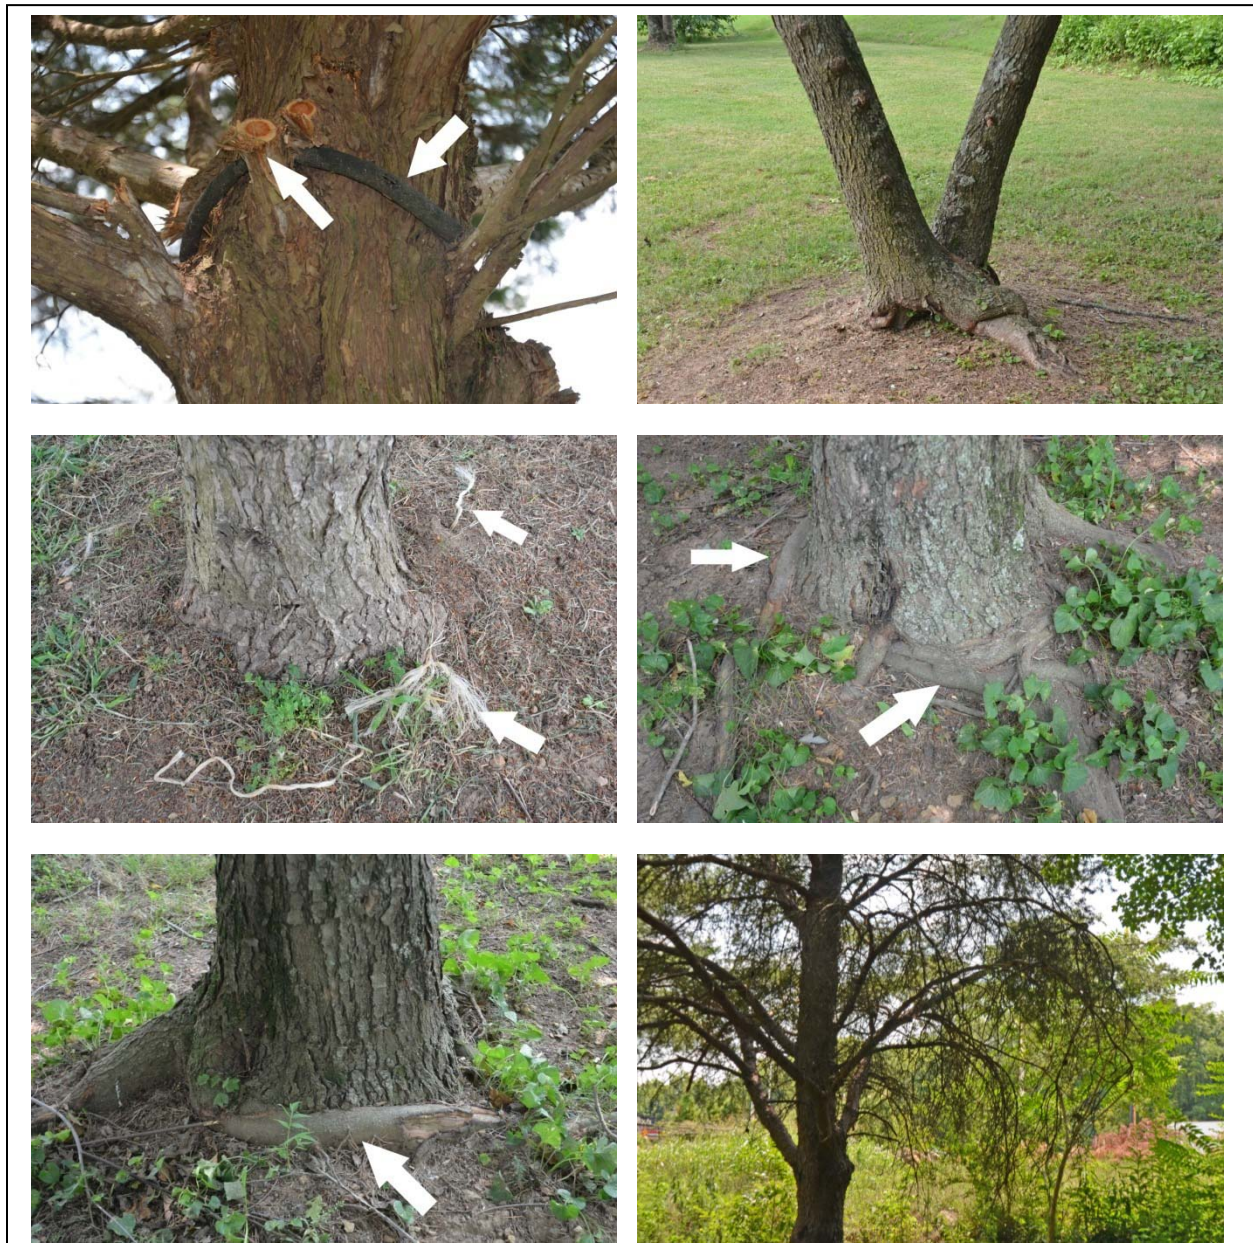
Figure 52. Additional tree issues at Rest Haven Cemetery. Upper left shows a cedar with an abandoned strap left in place. Note also improper pruning that left a stub. Even during pruning no effort was made to remove the choking strap. Upper right shows a tree with a weak crotch and girdling roots. Middle left shows nylon strings from balled roots left in place. Middle right shows multiple girdling roots. Lower left shows girdled roots. Lower right shows dead and dying branches on a tree requiring pruning.

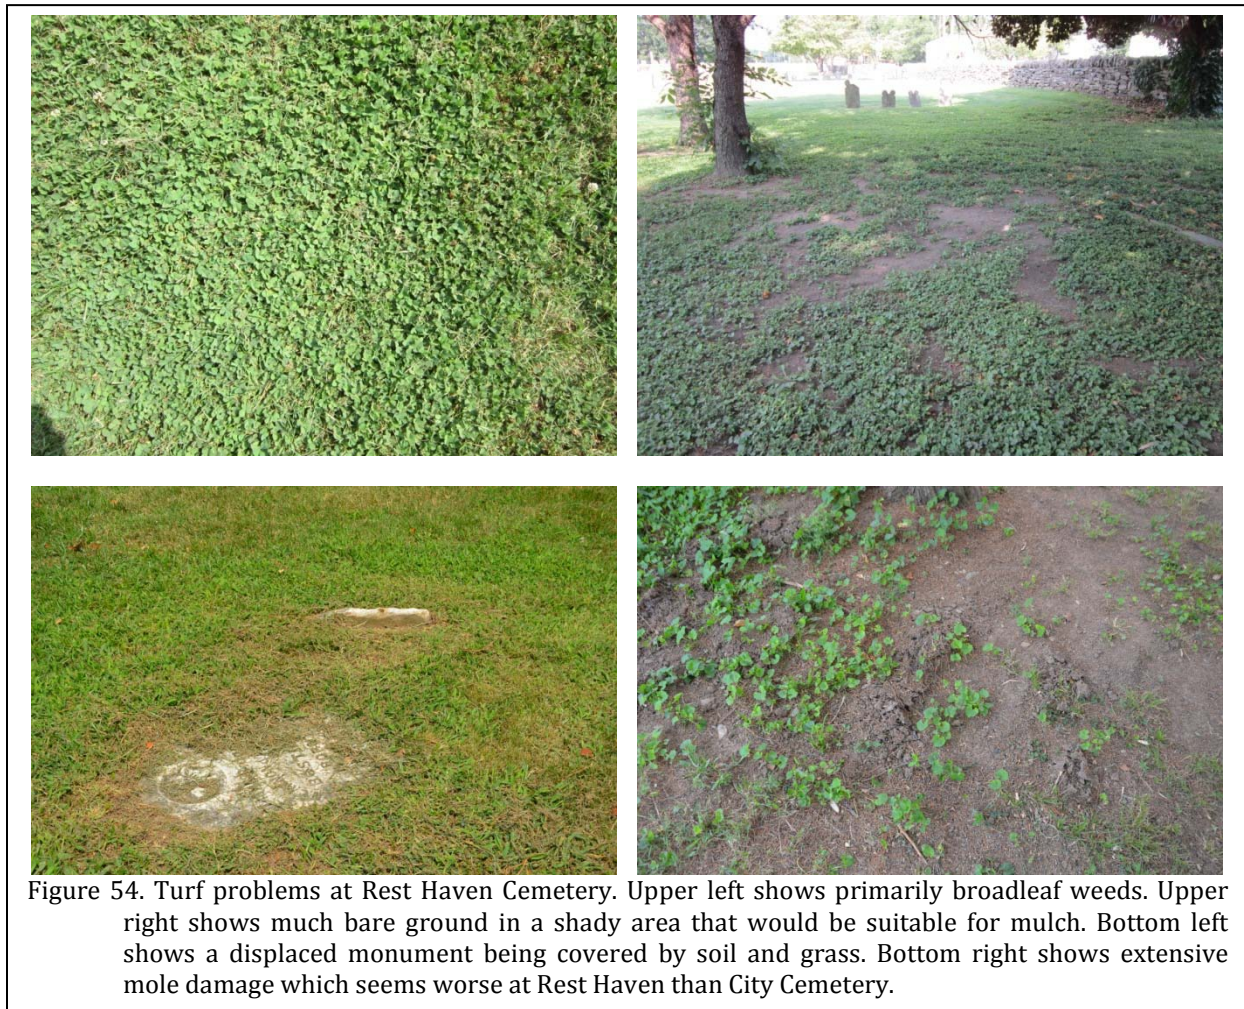
Figure 54. Turf problems at Rest Haven Cemetery. Upper left shows primarily broadleaf weeds. Upper right shows much bare ground in a shady area that would be suitable for mulch. Bottom left shows a displaced monument being covered by soil and grass. Bottom right shows extensive mole damage which seems worse at Rest Haven than City Cemetery.

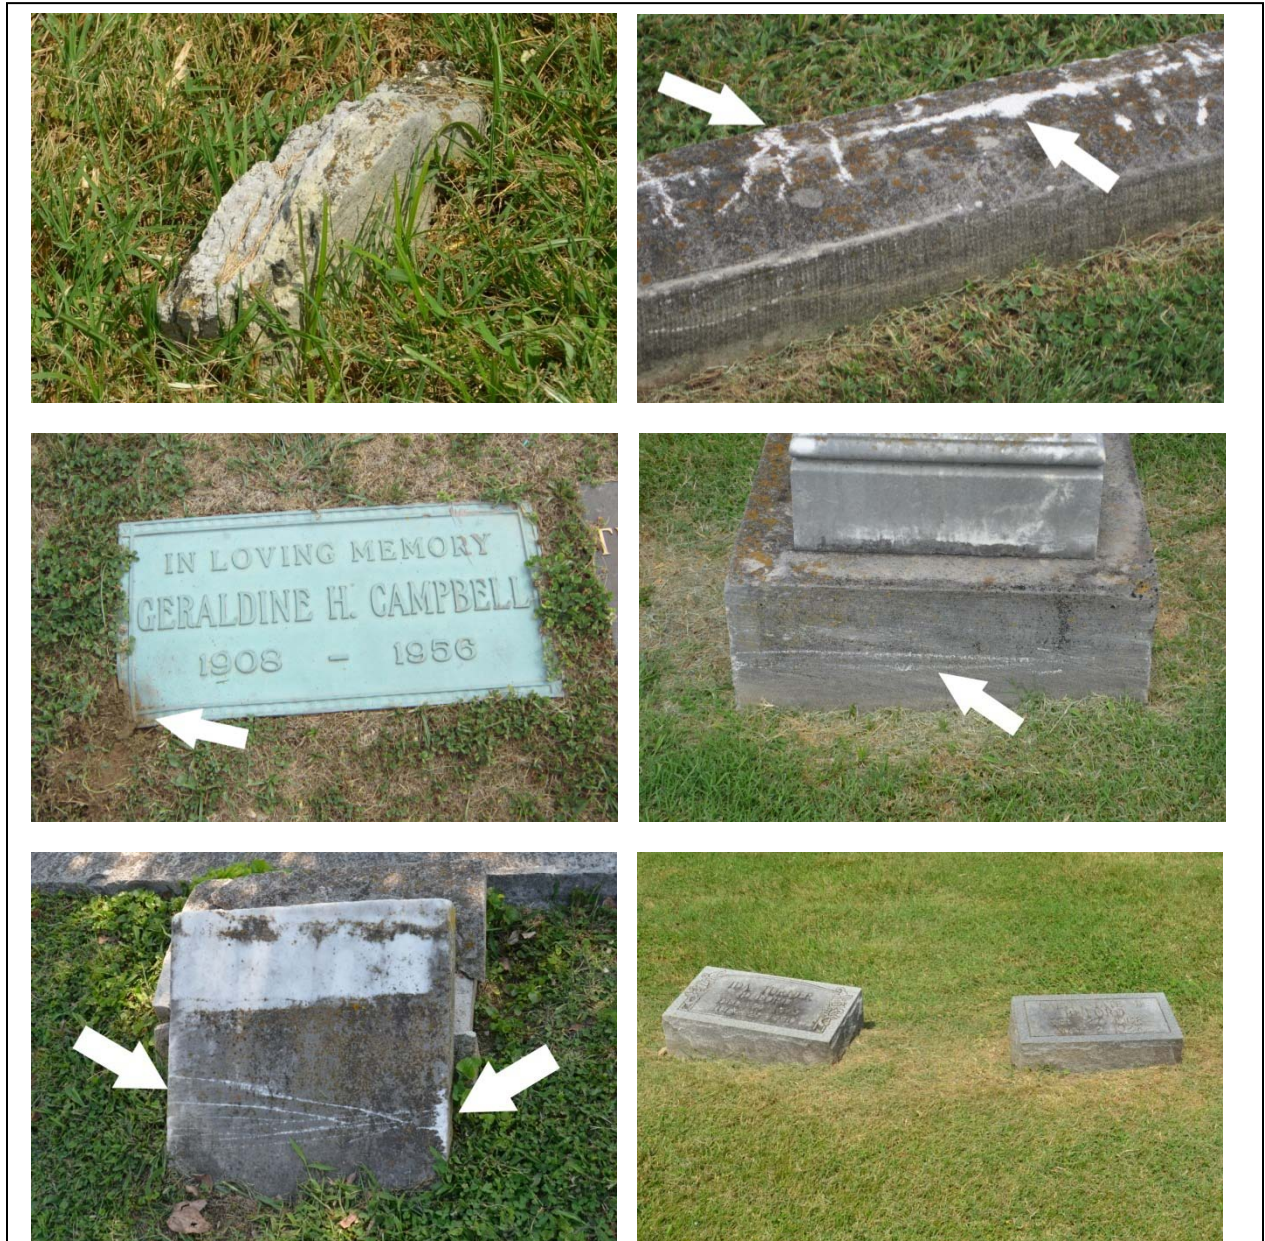
Figure 55. Mowing damage in Rest Haven Cemetery. Upper left shows a footstone repeatedly run over by mowers fragmenting and destroying the top. Upper right shows coping repeatedly impacted by mowers running over it. Middle left shows a bronze lawn marker damaged by a mower. Middle right shows a monument scraped by a mower. Bottom left shows both mower impacts and mower scrapes on a toppled monument. Bottom right shows a lawn marker displaced by mower impacts.

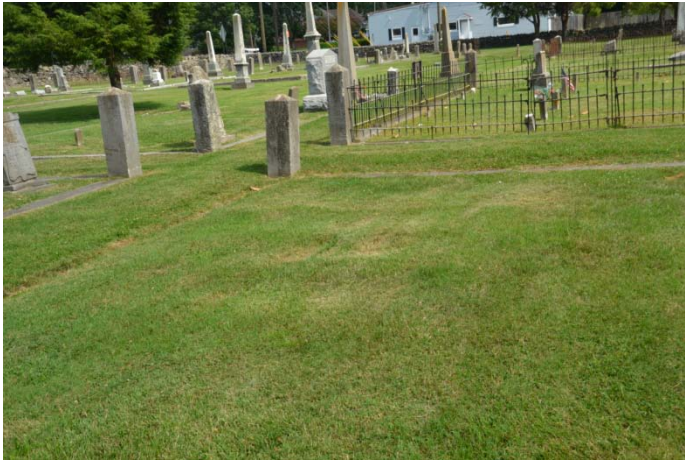
Figure 56. Grave depressions in a lot.
